OFFSHORE REPAIR OF A RISER PIPE

12" T-pipe on an offshore platform.

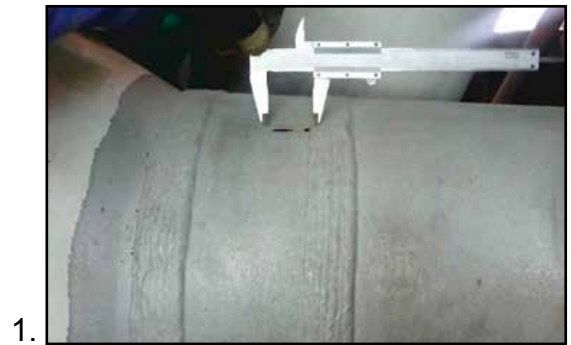
Cavitation near the flange, erosion between flange and T-section. Surface preparation created through wall defects because of the thin remaining thickness of the pipe at some points.

1. Before repair
2. During internal application
3. External repair - plate bonding
4. Finished repair
