BELZONA 1341 SUPERMETALGLIDE PROTECTS RUDDERS

Rudders

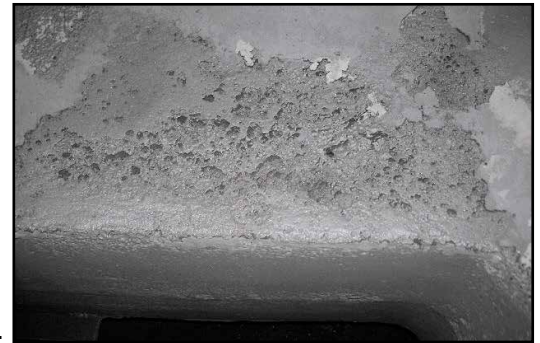
Rudders were showing sever metal loss in areas where cavitation attack prevalent .

1. View of one of the many badly cavitated areas on the two rudders
2. Rebuilding of eroded areas in progress
3. Application of 1st coat of Belzona 1341 in progress
4. Application of 2nd coat of Belzona 1341 completed
