BELZONA REBUILDS AND PROTECTS FERRY RUDDER HORNS

CUSTOMER
BC, Canada

APPLICATION DATE
December 2004

APPLICATION SITUATION
Rudder Horns

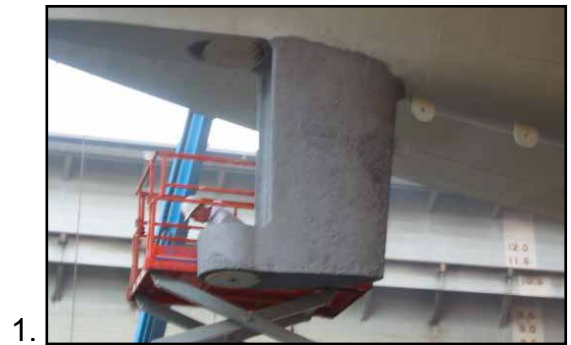
PROBLEM
The rudder horns are subject to both erosion and cavitation damage.

1. Rudder horn after grit blasting to a near white metal finish
2. Application of 1st coat in progress
3. Completed application

PRODUCTS
Belzona 1311 (Ceramic R Metal) Belzona 1341 (Supermetalglide)

APPLICATION METHOD
Application carried out in accordance with Belzona Know-How System Leaflet SOS-1/2
