BELZONA REBUILDS BOW THRUSTER

Bow thruster

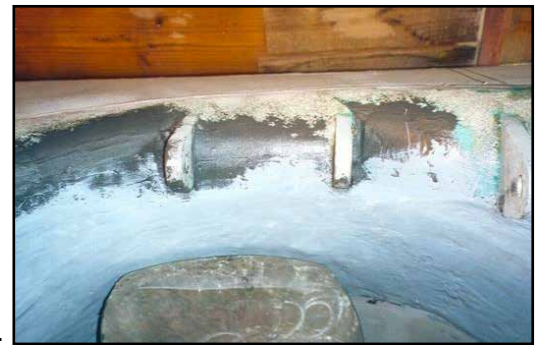
The fiberglass surround designed to eliminate bimetallic corrosion around the bow thruster insert was not able to protect the area from cavitation attack.

1. Fairing in the damaged areas
2. Fairing in the damaged areas
3. Entire bow thruster protected with 2 coats of Belzona 1341 Supermetalglide.
