BELZONA PROTECTS RUDDERS

Rudders

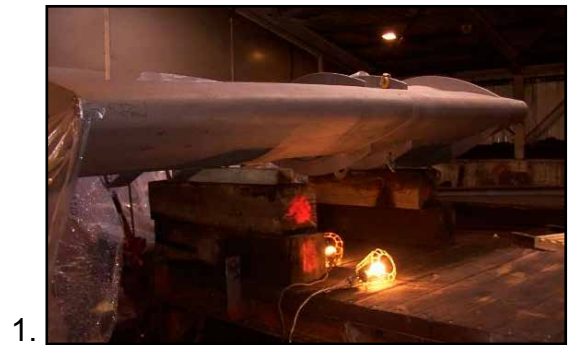
1. Rudder after grit blasting
2. Excessively cavitated areas are rebuilt with Belzona 1311 before being over coated with Belzona 1341 Supermetalglide
3. Final coat of Belzona 1341 Supermetalglide (Grey) applied and force cured with heat lamps to meet deadline.
