## BELZONA REBUILDS AND PROTECTS RUDDERS

Rudder

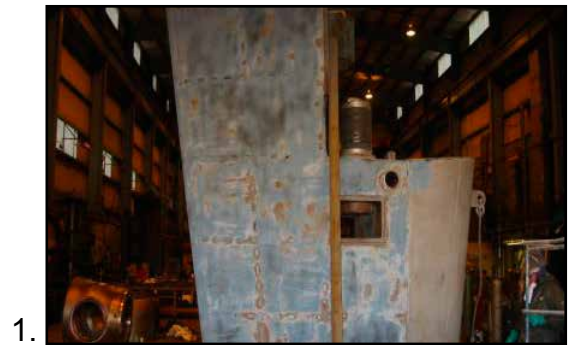
1. Rudders in set up after blasting ready for application
2. Rudders after application of 2 coats of Belzona 1341 Supermetalglide
3. Condition of rudders / rudder horn after 2.5 years in service with Belzona coating.
