BELZONA REBUILDS DAMAGED LOADING BAY

Valve Manufacturer, Haywards Heath, UK

September 2014

Damaged loading bay

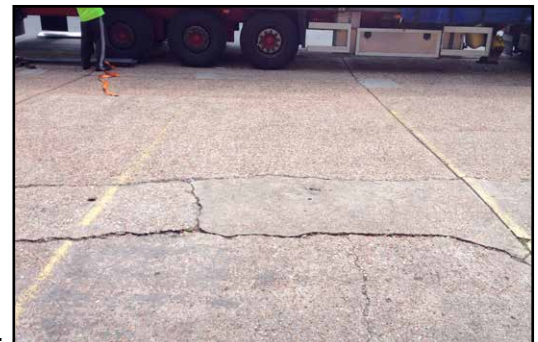
The loading Bay to this factory has a gradient leveling off down at road level. When lorries load and unload they have to reverse from the road up the gradient and into the loading area. At the start of the gradient lorries wheels lose traction causing abrasion and damage to the concrete. To overcome this, lorries take the run-up to the loading Bay, resulting in damage to the loading bay wall and potential injury to personnel. Over time the damage to the concrete slab has worsened making loading and unloading much more hazardous.

1. Damaged concrete
2. Incline of loading bay
3. Completed Application
4. Completed Application

The application was carried out in accordance with Belzona Know How System .1. After surface preparation to remove any loose concrete, Belzona 4911 was applied to the entire area followed by a layer of Belzona 4131.
