BELZONA REPAIRS AND PROTECTS BULB GENERATOR SET

Hydropower Plant - France

Bulb generator set.

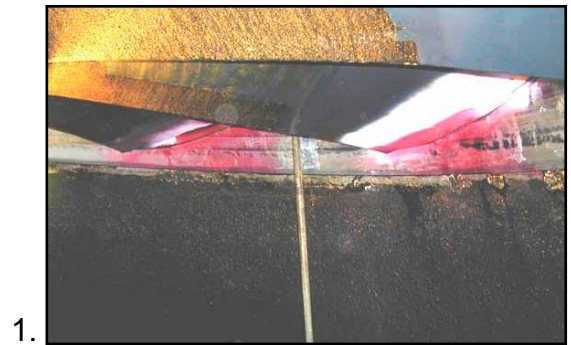
Important infiltration and corrosion between stainless steel jacket and turbine housing.

1. General view of the housing
2. Junction between steel and stainless steel
3. Completed repair and protection

The damaged junction was repaired with Belzona 1111 and protected with Belzona 1341. The application was completed by the customer.
