BELZONA PROTECTS CYCLONE

Inside a cyclone transporting corncobs in a cereal plant.

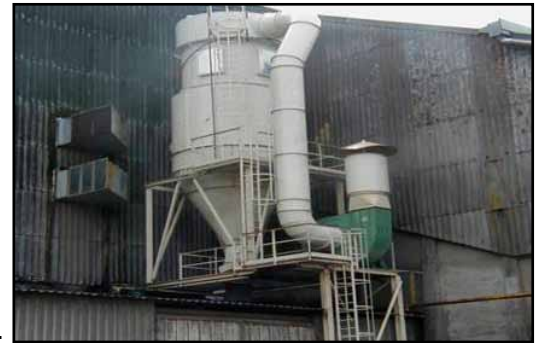
1. Cyclone to be repaired
2. Presence of holes due to abrasion
3. Repair with Belzona 1311 and protection with Belzona 1321

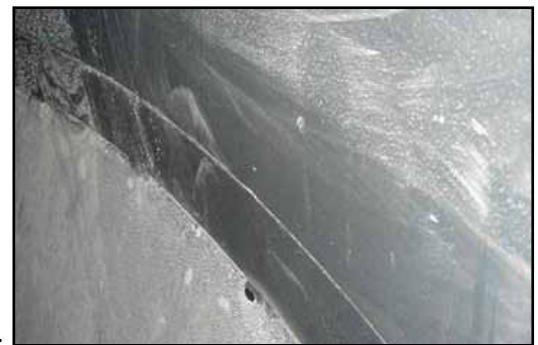
Abrasion inside the cyclone and through-wall damages caused by corncobs.
