BELZONA PROTECTS BUFFER STONE WITH INTERNAL COATING

Refinery, France

Buffer store with a diameter of 3m and length of 11m, transporting crude oil.

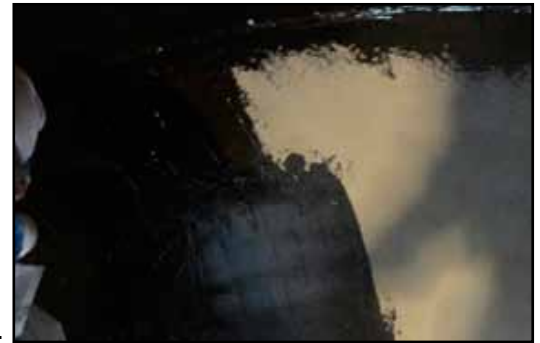
1. Application on grit-blasted substrate
2. Completing the application on the top part of the tank
3. Inspecting the thickness of the coating

The application was carried out during a shutdown of the refinery. The entire application was completed in a one coat system.
