BELZONA SOLVES LEAKING PROBLEM ON GAS PIPE

Gas Distribution Company, Stuttgart, Germany

Flange on natural gas pipe (diameter of the flange 1.30m).

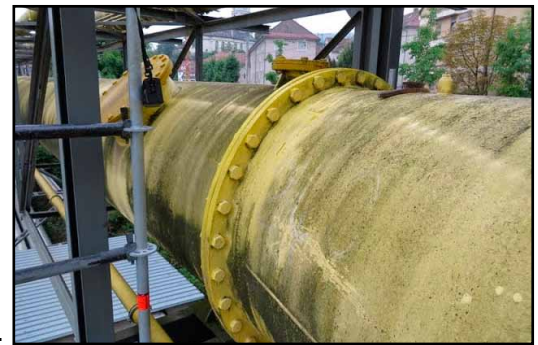
1. Flange prepared for the application
2. Bolted caps, sealed gap and embedded screw
3. During application of the first coat of Belzona 3411
4. After application of the second coat of Belzona 3411

The substrate was manually prepared as described in the IFU and the application was carried out in accordance with Belzona Know-How System Leaflet GSS-11. The embedded screw helped for releasing the gas pressure until the application was cured. Belzona 8411 was not used because the customer does not require the protection to be reopened or to be inspected in the future.
