BELZONA SAVES COAL DRYER EXHAUST FAN

This fan handles hot exhaust from a gas-fired dryer at a coal mine.

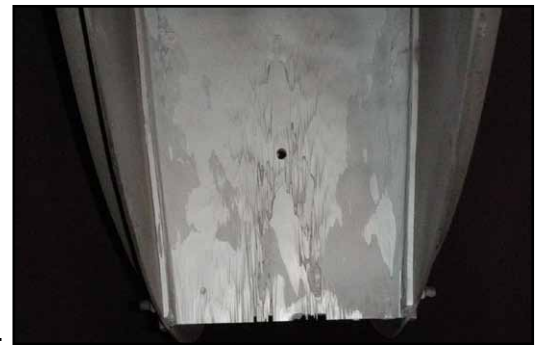
Exhaust contains fine coal dust and moisture, which erodes the fan blades, including the AR steel blade protectors.

1. Worn out AR plate; Belzona 1311 applied several years prior is still evident. Note missing bolt.
2. Rebuilt and coated with Belzona 1311 and 1391, respectively.
3. Completed application without disassembly and in one shift.
4. Belzona application intact after 6 months in operation.
