## BELZONA REPAIRS VOITH SCHNEIDER PROPULSION UNIT

A Voith Schneider unit from a passenger ferry.

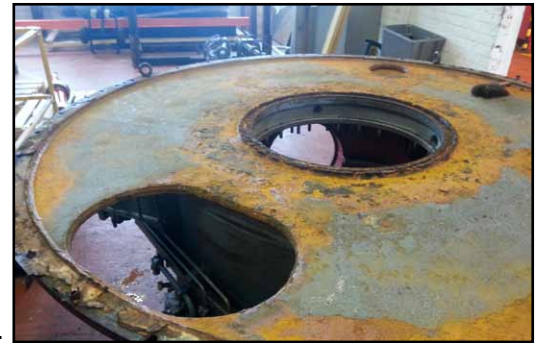
The combination of sea water and erosion from silt and sand was creating an erosion-corrosion cycle. Extensive metal loss had been noticed on the face of the equipment and on the inner rims.

1. Voith unit before work started
2. The damage on the inner rim
3. Belzona 1311 applied & former in place
4. Former removed, rim rebuilt and face coated with Belzona 1321
