BELZONA REPAIRS LEAKS IN WATER FEATURE

Water feature.

Leaks in the water feature.

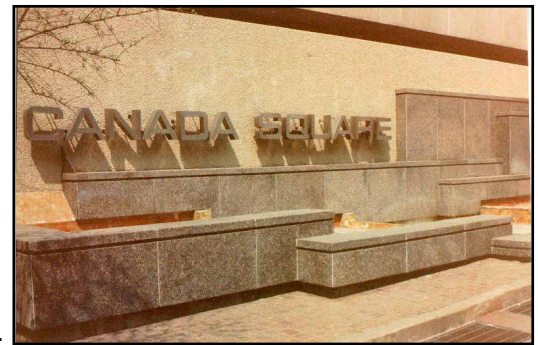
1. Water feature
2. Prior to application
3. Completed application
4. Water feature back in service
