BELZONA PROVIDES NON-SLIP SURFACE AT SCHOOL ENTRANCE.

School, Derbyshire

Worn Steps

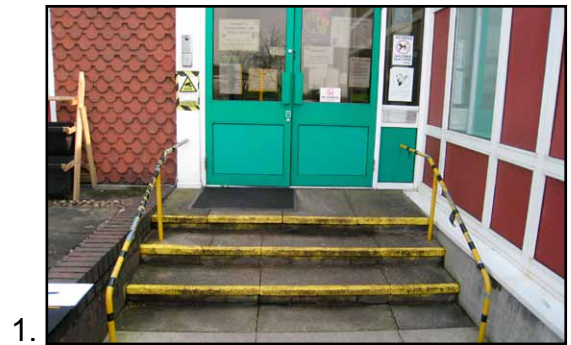
Steps presented a slip hazard to pupils, staff and visitors when entering and exiting the school.

1. Damaged Steps
2. Damaged steps - close up
3. Completed Application
4. Completed Application - close up

The application was carried out in accordance with Belzona System Leaflet FPA-8. Belzona 9221 was encapsulated in the Belzona 4411 and applied in an even coat.

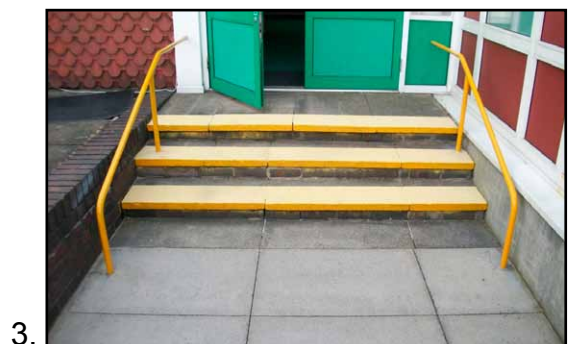
The school had used Belzona 4411 in the past and were pleased with the results and therefore chose Belzona again for this application. The entire application was completed in one day. The Belzona 4411 yellow provides a visual guide to the step nosings as well as a hard wearing non-slip surface.
