BELZONA PROTECTS POWER PLANT CONDENSERS

Power Plant, Bulgaria

Water boxes and tube sheets of two power plant condensers.

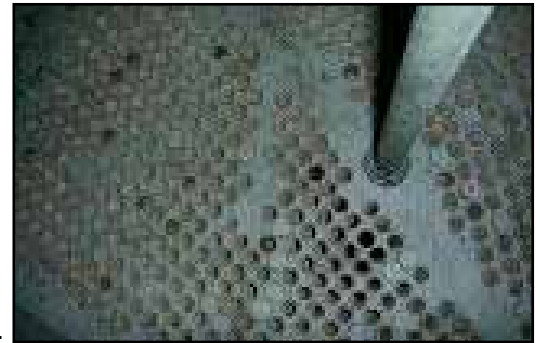
1. Surface preparation of tube sheet by blast cleaning
2. Coating of tube sheet with Belzona 1321
3. Application of first coat of Belzona 1341 to water box
4. Completed application to tube sheet and water box

Application was carried out in accordance with Belzona Know-How Leaflet HEX-3. Belzona 1321 was used to protect tube sheets from bimetallic corrosion and erosion from entrapped particles in the cooling water. Belzona 1341 was used to protect the water boxes.
