## BELZONA PROTECTS CO<sub>2</sub> ABSORBER TOWER

Fertilizer plant, Bulgaria

CO<sub>2</sub> Absorption tower 41m high, 4m diameter - lower part

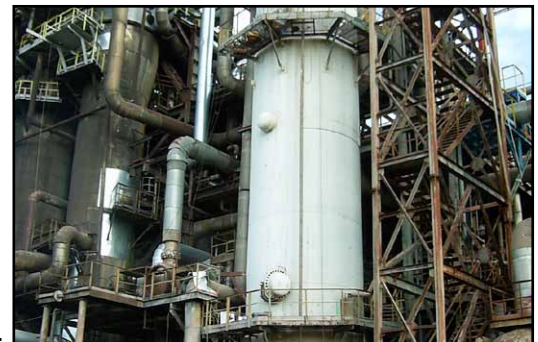
1. General view of the tower
2. Severe pitting was revealed after surface preparation by abrasive blasting
3. Application of the first coat of Belzona 1391 underway
4. View of the final application. Belzona 1391 was applied in two coats with grit blasting between the first and the second coat
