BELZONA MAINTAINS CORRODED SPRINKLER TANK BY PLATE BONDING

6m diameter x 6m high circular steel tank supplying water for the fire sprinkler system in a large foam manufacturing plant

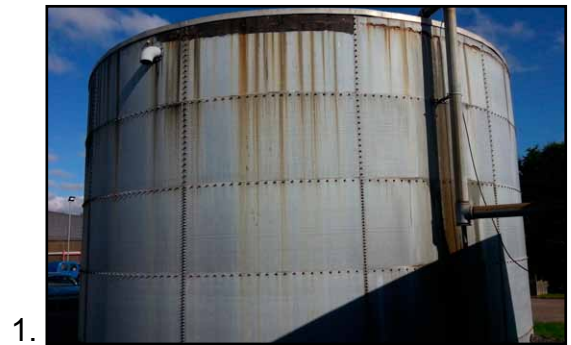
Over several years the tank had become badly corroded around approximately 50% of the circumference at the water line causing it to split open in some areas allowing water to flow out.

1. Large sprinkler tank with corrosion at water line
2. Surface being prepared with MBX Bristle Blaster
3. 400mm long x 300mm high steel plates being installed using Belzona 1161
4. Installation complete around tank circumference and coated with Belzona 5831
