BELZONA PLATE BONDING SOLUTION FOR SLUDGE TANK

Sewage treatment works, UK

Primary sludge tank fabricated from GFS (Glass Fused to Steel).

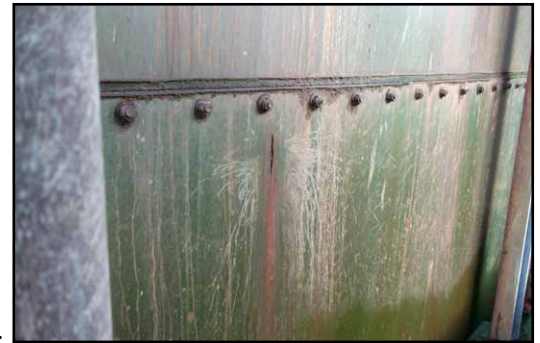
Tank was suffering from a through wall corrosion at the lowest panel level. The tank could not be taken off line due to demand and any repairs would have to be carried out without hot works or the use mechanical equipment due to the risk of sparks.

1. Through wall corrosion to primary sludge tank
2. Surface preparation carried out by hand abrasion
3. Repair plate cold bonded over the through wall corrosion using Belzona 1161
4. Completed application
