## BELZONA FORMS 2" 150PSI RATED FLANGES

Oil Major, North Sea, UK

Deck water seal of inert gas generator system on an FPSO. Seal handles sea water at ambient temperatures.

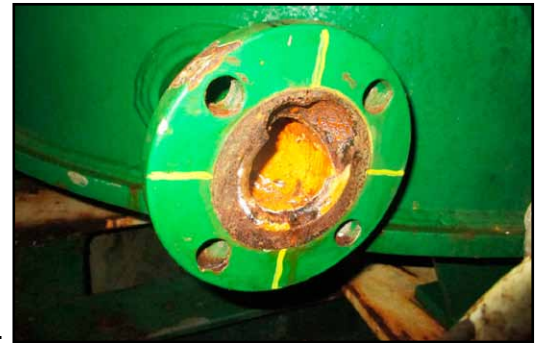
Existing coating had failed leading to corrosion of the vessel internals and severe loss of metal on the adjacent flanges.

1. Damaged flange face
2. Flange face after grit blasting
3. Belzona flange former in place
4. Completed application after removing former
