BELZONA FLANGE FACE FORMING ON 4” 150PSI FLANGES

Oil Major, North Sea, UK

Deck water seal of inert gas generator system on an FPSO. Seal handles sea water at ambient temperatures.

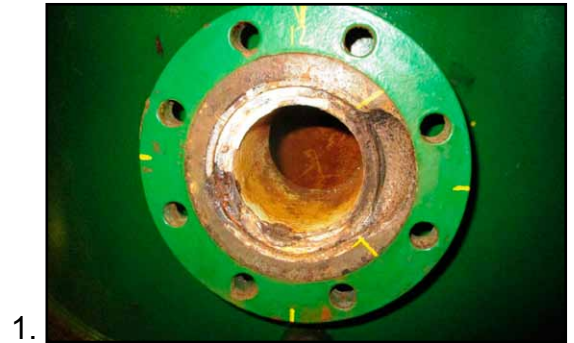
Existing coating had failed leading to corrosion of the vessel internals and severe loss of metal on the adjacent flanges.

1. Damaged flange face
2. Flange face after grit blasting and deep pitting roughly infilled with Belzona 1111
3. Belzona flange former in place
4. Completed application after removing former
