BELZONA FORMS 24" FLAT FACE FLANGE

Deck water seal of inert gas generator system on an FPSO. Seal handles sea water at ambient temperatures.

Existing coating had failed leading to corrosion of the vessel internals and severe loss of metal on the adjacent flanges. This 24 inch flange was for the Perspex sight port.

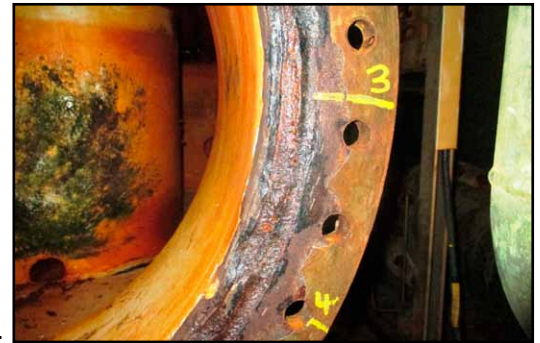
1. The damaged flange face. Note damage to internal lining
2. Aluminium former in place
3. Former removed showing reformed flange face with Belzona 1111
4. Flange re-assembled with Perspex window in place
