BELZONA PROTECTS WASTEWATER PUMP FOR 25 YEARS

Wastewater Treatment Plant, Vancouver, BC

Wastewater pump

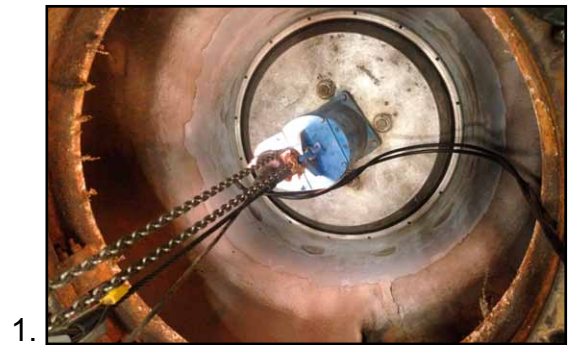
This wastewater pump was originally rebuilt in 1989 with Belzona when the lower portion of the pump bowl had eroded severely causing small pinholes to develop in the side casing.

1. The pump bowl after the lower portion had been grit blasted.
2. Rebuilding the lower bowl section with Belzona 1311 in progress.
3. Additional rebuilding underway.
4. The rebuilt areas and the entire lower portion of the bowl received 2 coats of Belzona 1321.
