## BELZONA PROTECTS PIPE WITH INTERNAL LINING

Oil and Gas Company, BA, Brazil

July 2009

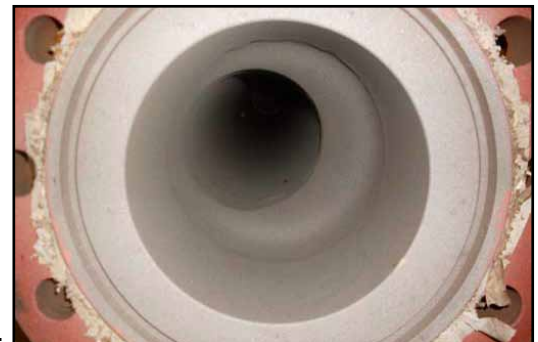
1. Internal surface after blasting.
2. Internal surface of the pipe coated with Belzona 5891.
3. Close-up after the application of Belzona 5891.
4. Overview of the pipelines.

The weld seams and irregularities were roughened by grinding. The internal surface of the pipes was prepared by blast cleaning to a near white metal finish, SSPC SP-10 Sa 2.5; standard. After the removal of residue and cleaning with a degreaser, Belzona 1121 was applied to smooth the weld seams/irregularities. Then the 1st layer of Belzona 5891 was applied at a thickness of 300-400 microns. After the initial mechanical stability of Belzona 5891, brush-off blast cleaning was carried out and the 2nd layer of Belzona 5891 was applied at a thickness of 300-400 microns. In the straight sections, the coating of Belzona 5891 was applied. Inspection was carried out and the identified misses were retouched.
