## BELZONA PREVENTS ROOF LEAKS ACROSS HOUSING ESTATE

Housing Association, Loughborough, UK

28 roofs of various sizes across the housing estate.

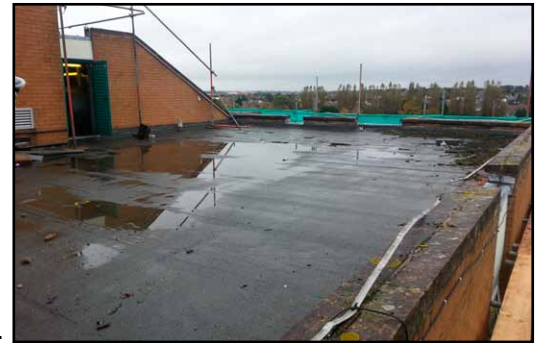
A previously applied competitor product was beginning to fail. Leaks in the roof were allowing water to flow behind lower concrete and brickwork. This caused damage to the roof structure as well as internal damage.

1. Roof without any form of protection
2. Half of the roof coated with Belzona 3911
3. Belzona 9311 laid out and Belzona 3111 being applied
4. Finished application

Application was carried out in accordance with Belzona Know How System Leaflets RPA-8 and RPA-10. All flashings were cleaned, and loose chippings on the felt were removed. Belzona 3911 was applied to the asphalt and Belzona 3921 applied to the lead flashings. This was followed by two coats of Belzona 3111 along with Belzona 9311 laid into the first coat.
