BELZONA PROTECTS TOOTHPASTE FACTORY FLOOR

Pharmaceutical Company, Maidenhead, UK

Pressure pot room where colour is added to toothpaste

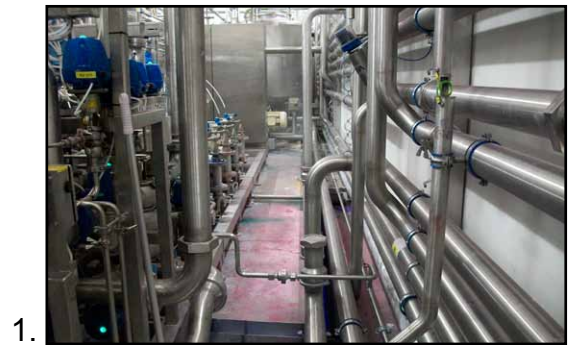
The originally applied protective coating on the floor had failed, due to the spillage of Flavour Oils and the use of caustic soda to clean the room daily. As a result, water/cleaning fluid was leaking through the floor and into the packing area below. The existing polyurethane coating was in most part still intact and showed good adhesion to the steel/aluminum chequer plate. The area's which have failed are where the floor is most exposed to the chemicals i.e. drain areas and flow paths. Access to some of the areas was restricted by pipe work and plant.

1. Damaged Floor
2. Washing to remove dye
3. 1st coat application
4. 2nd coat application
