WALL REPAIR OF CYCLONE FEED SUMP WITH BELZONA

Mine, Bolivia

June 9, 2011

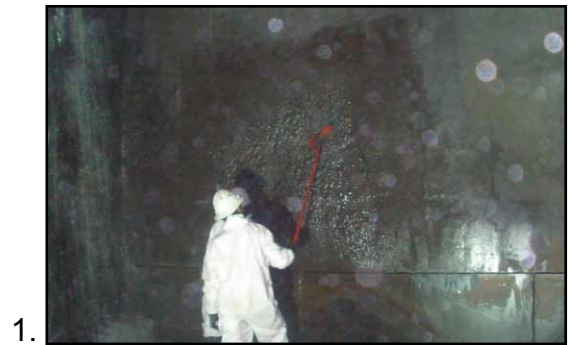
1. Preparation of substrate
2. Application of Belzona 4911
3. Wall repaired with Belzona 4111
4. Inspection on October 20, 2012

The application was carried out in accordance with Belzona Know-How System Leaflet FPA-1. The surface was prepared with a pressure washer and salt removal products. All loose material was removed and later dried with compressed air.

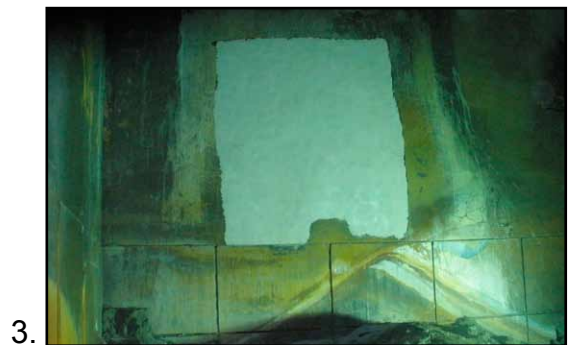
Damage on the wall of the cyclone feed sump, due to impact from the fall of ore and balls from mills.

Belzona 4111 provides high adhesion to the old concrete, exceptional resistance to impact, vibration, abrasion and chemical attack. To date the repair has not suffered wear or loss of thickness.
