## BELZONA REPAIRS PILLARS OF A RAILROAD TRACK

Steel Industry, Pará, Brazil

Recovery of 48 pillars.

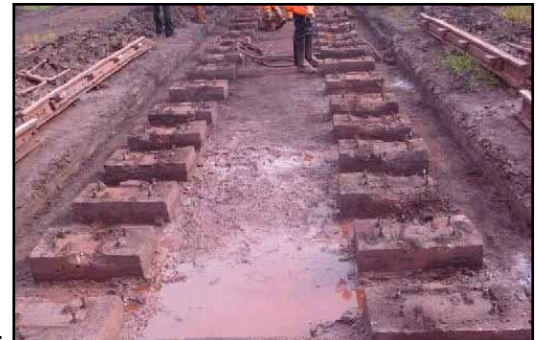
The area of the 48 deteriorated pillars negatively influence the operation of the railway.

1. General view of the damaged pillars
2. Installation of the forms to the pillars after cleaning
3. Application of Belzona 4111
4. Wagons operating on the repaired pillars
