## BELZONA 4111 BETTER THAN CONCRETE

Mass Transit Company, South Texas

Drainage channel at entrance to bus depot. "Speed hump" also required to control traffic entering depot

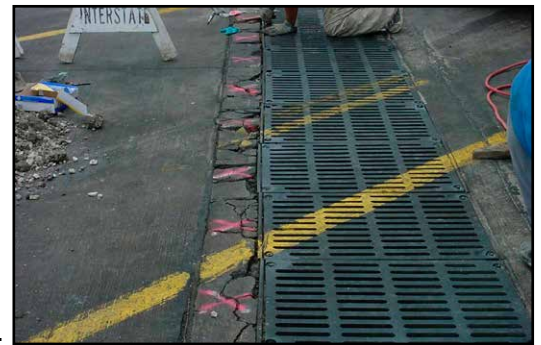
Heavy buses rolling over drainage channel cracked the concrete curb. Client also wanted to compare Belzona 4111 to concrete as a repair material in side by side comparison.

1. Damaged drainage channel curb
2. Area prepared and conditioned with Belzona 4911
3. Belzona 4111 layer in place
4. Completed application

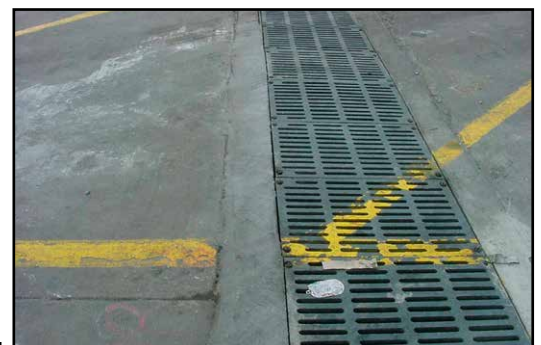
4.

After almost one year, Belzona 4111 still in tact while the concrete had not held up in this heavily trafficked bus depot. Repairs carried out quickly with minimal disruption to traffic.
