BELZONA 1812 PROTECTS FAN FROM EROSION

BC, Canada

July 2007

Eroded fan blades

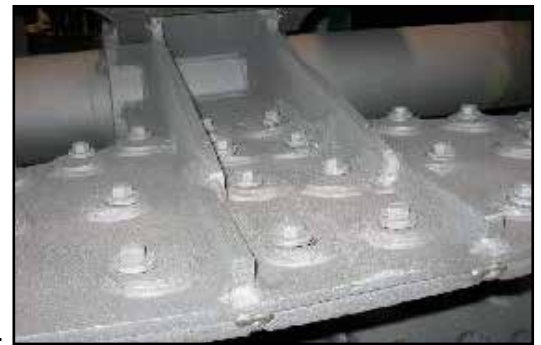
1. Fan assembly in lathe to allow easy application of product and to check on balance when complete
2. View of fan blade
3. Application of Belzona 1812 Ceramic Carbide FP to one side of the fan blade assembly
4. Application of Belzona 1812 Ceramic Carbide FP to the opposite side
5. Condition of the Belzona 1812 Ceramic Carbide FP application after approximately 15 months of service

Belzona 1812 was used to fill in eroded areas, fair in transitions to help prevent the swirl of entrained air from eroding away the parent metal of the fan.

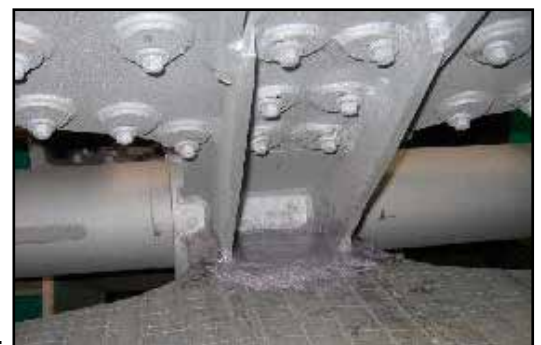
2.

Hot, moist air (110°C) carrying entrained dust was swirling behind and destroying the backs of the fan blades, eating away both the parent metal and the thick washers welded in place to help control the problem.
