BELZONA SOLUTION FOR FEED WATER PIPELINE

Oil Company, Oman

2013 - 2014

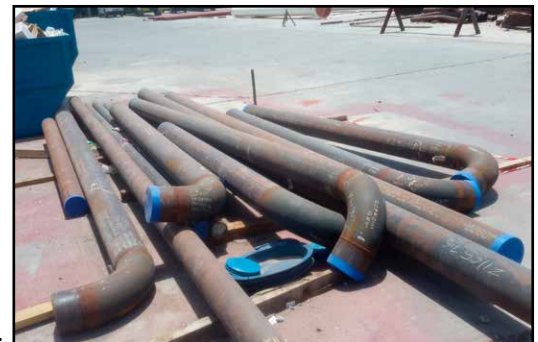
1. Pipeline sections
2. Spin spray rig
3. Pipeline sections being lined
4. Pipeline close up
