BELZONA ELIMINATES DAMAGE FROM CUI (CORROSION UNDER INSULATION)

Oil Refinery in U.K.

Outdoor condensate vessel.

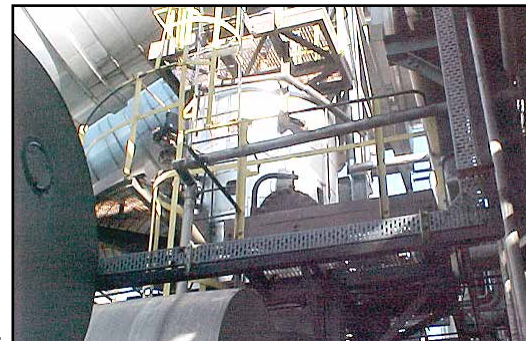
The vessel was suffering from CUI (Corrosion Under Insulation).

1. An overall view of the vessel, complete with lagging, while in service
2. Surface preparation was carried out via wire brush and power wire-brushing too.
3. Belzona® 5851 is being applied via brush
4. Close-up of application area. Showing brush strokes after one year of service
