BELZONA® PROTECTS FRACTIONATOR TOWER

Refinery in Singapore

Fractionator tower in cracker unit.

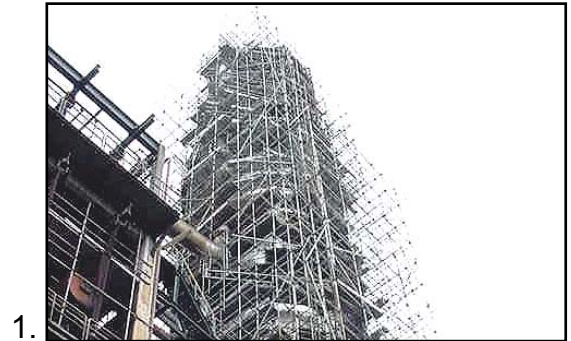
1. General view of the tower.
2. The degree of corrosion clearly evident on the support rings.
3. Application underway.
4. Application complete.

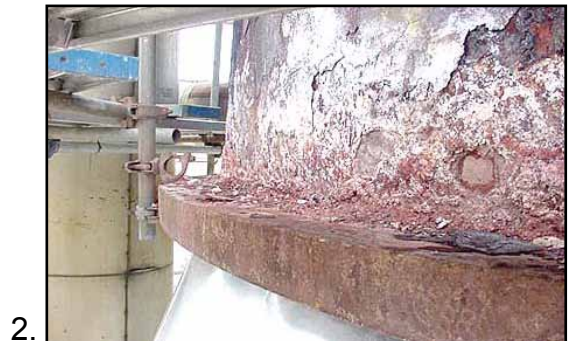
CUI (Corrosion Under Insulation) particularly around the support rings where moisture had accumulated.
