## BELZONA® GETS THE NOD WHEN DOWNTIME MUST BE MINIMIZED

Geothermal Plant in the Philippines.

Anchor casing

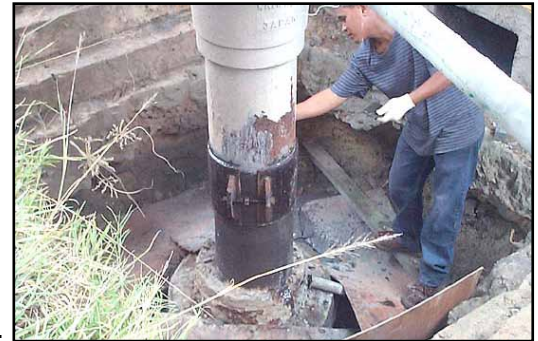
1. Pitted areas are rebuilt with Belzona® 1251 prior to Belzona® 5851 application.
2. Belzona® 1251 is heat cured in service with adhesion strength of 3200 psi.
3. Final coat of Belzona® 5851 for extra protection.

Manual surface preparation was used. Next, a new metal jacket was placed over the heavily pitted areas and bonded in place with Belzona® 1251. After the material began to cure, Belzona® 5851 was used to coat the entire area for extra protection.
