## CORRODED PIPEWORK: A THING OF THE PAST WITH BELZONA® 5851 (HA-BARRIER)

Oil refinery in New Zealand

Corroded pipework and columns.

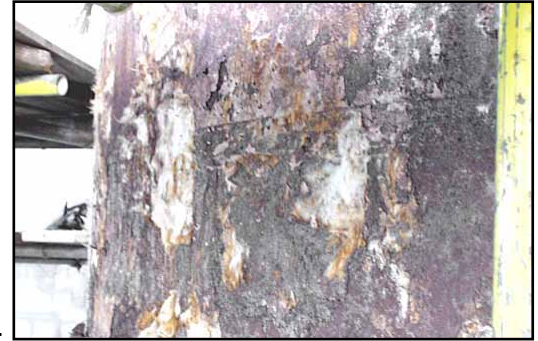
CUI (Corrosion Under Insulation) was causing costly shutdowns to under-take repairs.

1. Prior to application, corrosion can easily be seen.
2. & 3. Belzona® 5851 is easily applied to hot surfaces by trowel, brush, or even spray.

Manual surface preparation was done with high pressure water blasting. Belzona® 5851 (HA-Barrier) was applied directly to hot pipework while in service.
