PROVEN BELZONA SUCCESS ON CONDENSATE TANK PROTECTION

University, Southeast Wyoming

Condensate tank, part of the Universities hot water system. Tank operates at 200°F, peaking up to 300°F under upset conditions.

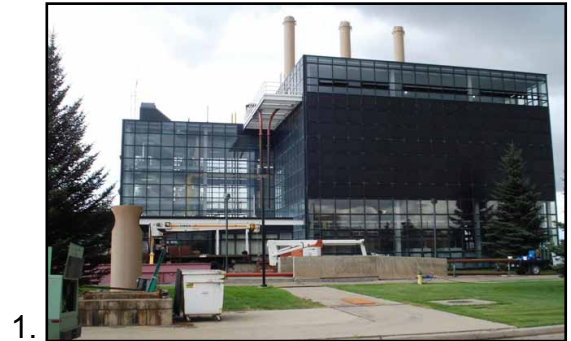
1. Universities hot water plant
2. Original Belzona coating application
3. Touch-ups on tank walls
4. Touch-ups On tank floor

Original Belzona application was carried out in 2008. In August 2010 the application was inspected and only minor touch ups were required where underlying concrete had cracked.
