BELZONA PROTECTS SUGAR BEET MIXER SHAFT

Sugar beet factory, Switzerland

Mixing shaft with 46 half shells on which agitating arms were located

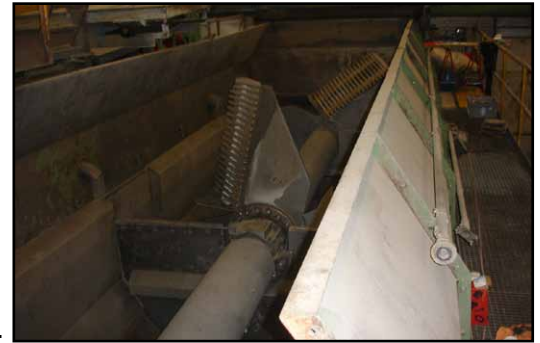
Loose particles of soil and small pieces of rock, released during the processing of the sugar beet causes abrasion on the shaft.

1. Shaft after removal of half shells and agitating arms
2. Application of Belzona® 1121
3. Application of Belzona® 1811
4. Completed shaft with agitating arms screwed back in place
