## COLD PLATE BONDING WITH BELZONA RESTORES SUMP TANK

Offshore Production Platform, Gulf of Mexico

Sump Tank Bottom deteriorated by external corrosion.

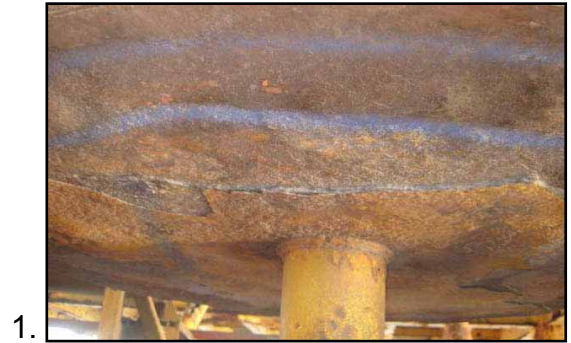
Exposure to the elements and oil & gas process systems caused severe corrosion to exterior of sump tank bottom. Damage resulted in thin wall and through hole areas.

1. Corroded tank bottom
2. Sump bottom after blasting
3. New bottom jacked into place
4. Bonding completed
