## BELZONA REPAIRS EBONITE LINING IN ACID STORAGE TANK

Chemical manufacturer, Cataluña, Spain

October 2010

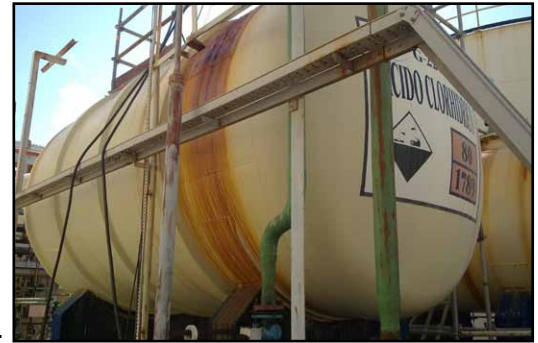
1. Outer view of the tank to be repaired
2. Damaged area of Ebonite
3. Local rebuilding of ebonite with Belzona® 4301 after surface preparation
4. Ebonite coated with Belzona® 4311

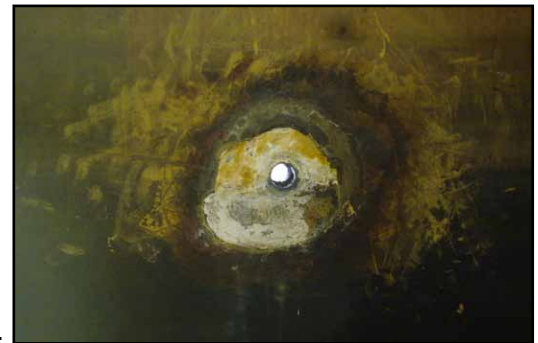
2.

The Ebonite coating in a tank containing 26%Hydrochloric acid had localised damage (cracks, grooves, seam failures, adhesion problems) due to the acid contents of the tank.
