BELZONA REPAIRS AND WATERPROOFS OFFSHORE ROOF

Corroded living quarters roof on offshore platform.

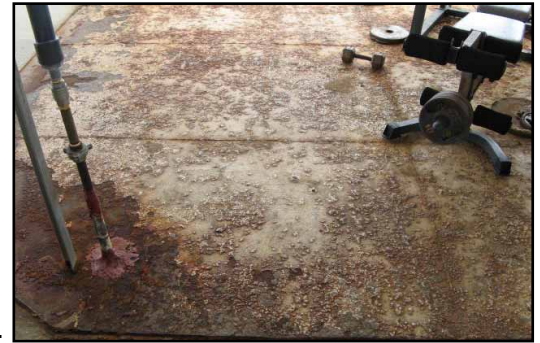
Customer seeking roof repair and installation of waterproofing system without disrupting oil and gas production. Metal roof had severe corrosion resulting in thin wall and some holes through the plates.

1. Roof showing severe corrosion
2. Roof after grit blasting
3. Roof after repairs and first coat Belzona 3111
4. Roof after completion

Application was carried out in accordance with Belzona System Leaflets RPA-1, RPA-6 and TCC-1. Belzona 1121 was used to bond doubler plates over thinned and holed areas before applying a fully reinforced Belzona 3111 System over the entire area.
