NOZZLE IN ACID TANK PROTECTED WITH BELZONA INSERT

Chemical manufacturer, Cataluña, Spain

Nozzle into Hydrochloric acid storage tank at Caustic soda producer

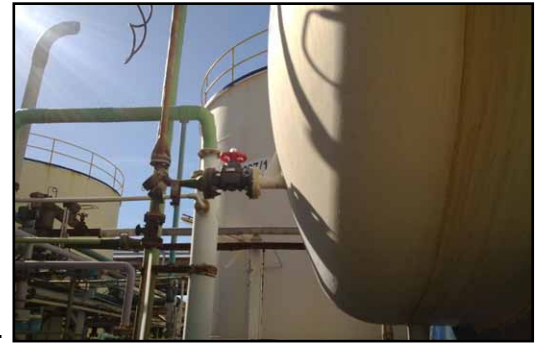
The interior of an ebonite lined nozzle handling 26% Hydrochloric acid had suffered damage.

1. Outer view of the tank and nozzle
2. Belzona® 4301 Nozzle Insert being installed
3. Surrounding Ebonite rebuilt with Belzona® 4301 to seal the insert
4. Insert sealed at the flange
