## BELZONA REPAIRS NEW HEAVY EQUIPMENT TIRE

New front end loader being delivered to the local dealership.

When the transport unloaded this brand new loader, the tire was damaged.

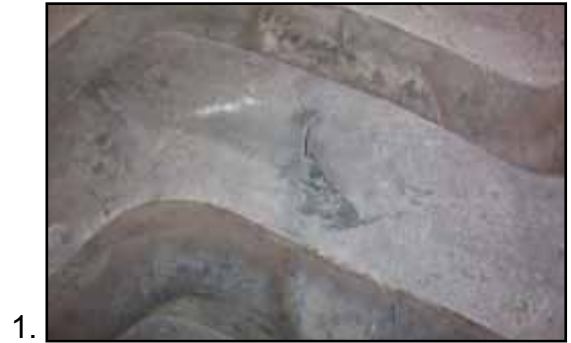
1. Damaged portion of the tire
2. Roughened surface
3. Surface conditioned
4. Tire rebuilt with Belzona® 2311
