## BELZONA PROTECTS WATER TREATMENT PLANT FILTER

Water treatment plant, Girona, Spain

Filter for removing organic matter.

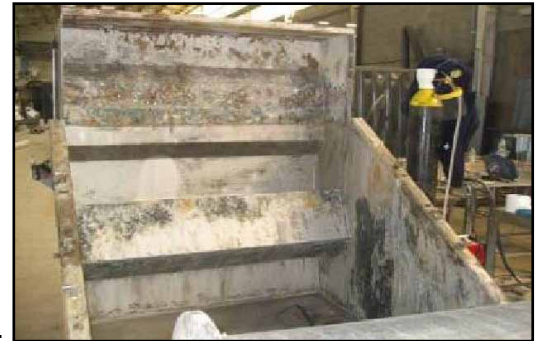
Severe corrosion of the stainless steel substrate due to the presence of Hydrogen Sulphide and Sulphuric acid. These are created by bacterial action in the organic matter.

1. Initial state of the sieve
2. Rebuilding with Belzona® 1121
3. Application of the second coating of Belzona® 4311
4. Finished unit

Application was carried out in accordance with Belzona Know-How System Leaflet TCC-5. After grit blasting, deeply corroded areas were rebuilt using Belzona® 1121 followed by coating with two layers (grey and red) of Belzona® 4311.
