BELZONA OFFERS COLD REPAIR SOLUTION TO PIPEWORKS

Refinery in France

2006

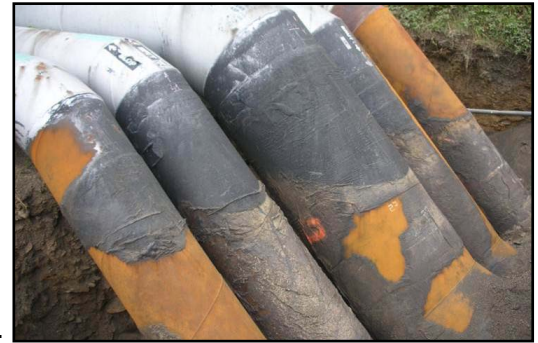
Previous coating did not last and external corrosion of the pipework was extensive.

1. Failure of the previous coating
2. Repair using Belzona® 1121 and reinforcement tape
3. Extra corrosion protection being provided with Belzona® 5811 coating
4. Repair completed
