PROTECTION OF DISTRICT HEATING SYSTEM

Electricity utility, Sweden

Access chamber (5 x 5m) to district heating pipework.

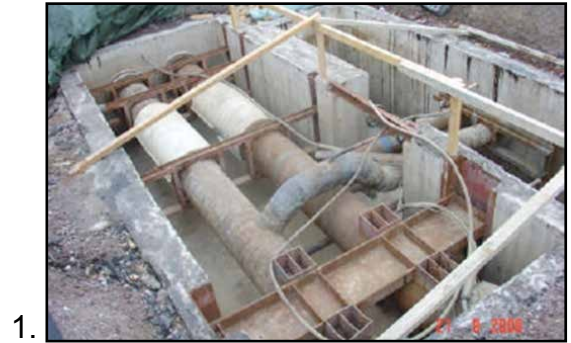
Corrosion on feed and return pipes as well as on supporting steelwork. System is in continuous use so products capable of application to hot surfaces required.

1. District heating Chamber before renovation
2. Dry ice blasting
3. Coating being applied
4. The finished application
