BELZONA REJUVENATES STEEL PLANT ACID & CAUSTIC BUNDS

Steel Plant, Teesside, UK

Basic Oxygen Steelmaking (BOS) Demin water plant. Two bunds for regeneration chemicals - 96% sulphuric acid and 46% Sodium hydroxide.

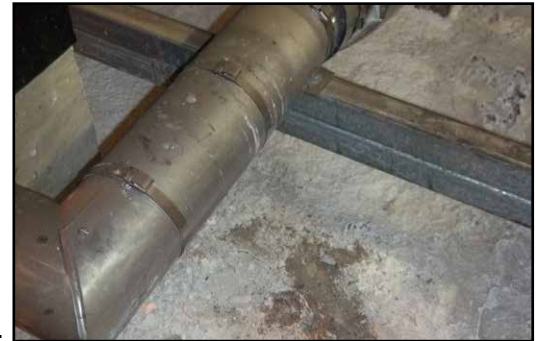
The two bund areas needed complete refurbishment. Over the years acid and caustic residues had attacked the bunds and left them both badly deteriorated. The client wanted the area cleaned and protected with a material that would resist further attack.

1. Original condition with Acid & Caustic attack
2. Fillet created in Belzona® 4131
3. Finished system in Belzona 4311
4. Acid and Caustic bunds completed in Belzona® 4311
