WORLDS LARGEST PHOSPHORIC ACID PLANT USES COST EFFECTIVE BELZONA SOLUTION

Phosphoric acid plant, Orissa, India

December 2010

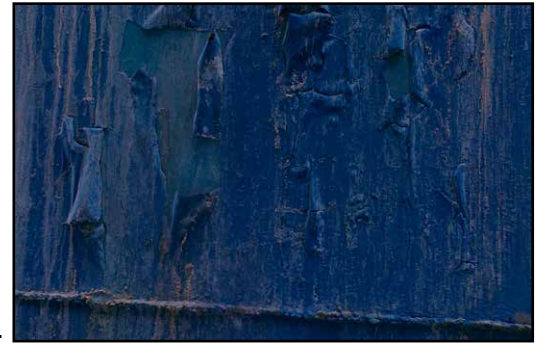
Standard Epoxy paints were peeling off within 6-8 months and outside of storage tanks get heavily corroded, mainly on the bottom portion at a height of 2 metres from the foundations.

1. Deterioration of existing coating on Phosphoric acid storage tank clearly evident
2. Surface preparation done by grit blasting
3. Application of Belzona® 4311
4. Finished application
