BELZONA "DELIVERS" A SANITARY FLOORING SOLUTION

Church charity organization, Texas

2006

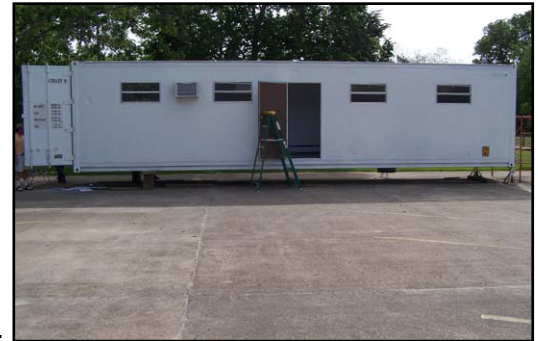
Charitable members of a Texas church were fabricating a portable birthing trailer that would eventually be shipped to Guatemala in an effort to offer a sanitary medical facility for use in an impoverished area that suffered from a high birthing mortality rate.

1. The portable birthing center
2. Floor prior to coating with walls taped off
3. Finished Belzona® 5811 flooring application

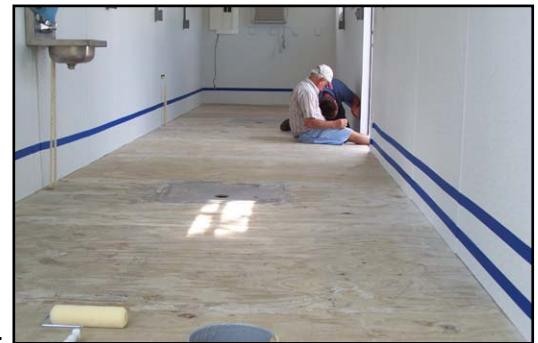
2.

The raw plywood floor with no sealant would be difficult to maintain and keep clean in an area that required a very sanitary environment.

Application was carried out in accordance with Belzona Know-How System Leaflet FPA-3. The walls were taped off approximately 2 inches up the vertical edge, sanded, cleaned then coated with two coats of Belzona® 5811 with minimal Surefoot aggregate added during the first coat process.
