## BELZONA RESEATS WEAR RINGS WITHOUT MACHINING

Water treatment plant, Canada

Wear rings of a Worthington pump needed repairs on site.

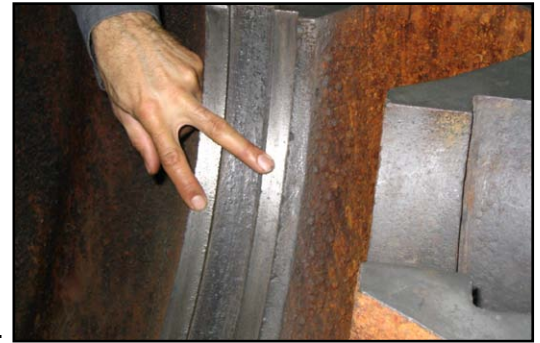
Erosion of wear ring seats caused vibration to the pump which needed repairs on site.

1. The wear ring seat
2. Release Agent applied to wear rings assembled on impellor
3. Surface preparation underway
4. Final result: no machining required
