BELZONA REPAIRS ARMY VEHICLE

The Jackal, a high mobility army vehicle used in Afghanistan by the British Army

The vehicle's gearbox casting was porous leading to unacceptable oil loss.

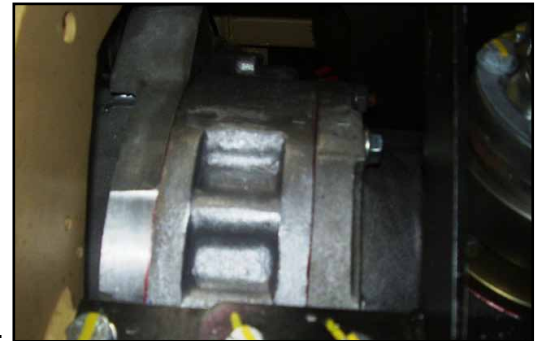
1. The Jackal
2. The porous gearbox casting before application
3. The gearbox sealed with Belzona 1161

The Belzona repair was completed without heat and without removing the gearbox. Belzona 1161 surface tolerant properties makes it ideal for this type of repair where oil contamination may be difficult to completely remove.
